# TechData Sheet

TDS-2058-SHR

## A CONCRETE SOLUTION TO THE F/A-18 PARKING APRON PROBLEM

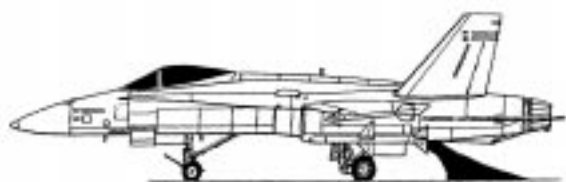
Damaged Area

Figure 1. F/A-18 Exhaust Profile

The high temperature exhaust gases from the Auxiliary Power Unit (APU) of the F/A-18 aircraft coupled with spilled fluids from this aircraft damage ordinary Portland cement concrete airfield pavements (Figure 1). The damage occurs progressively to the pavement surface due to repeated thermal cycling and chemical reaction of the spilled aircraft

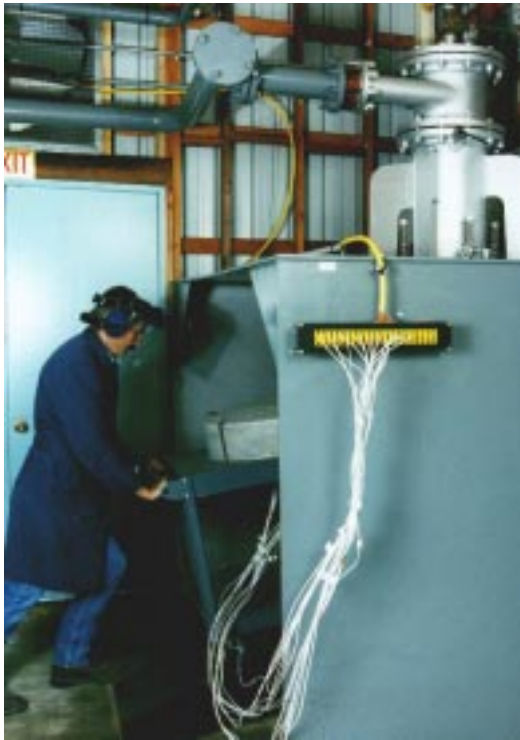
Figure 3. NFESC High Temperature JES Facility Setup

Cyclic exposure tests of the specimens were conducted in the NFESC High Temperature Jet Exhaust Simulation Facility (Figure 3). The simulated jet was calibrated to replicate the heat flux from the F/A-18 APU exhaust on ordinary concrete pavements. That heat flux produces a concrete surface temperature of 325°F after ten minutes of exposure. The thermal gradients present during the pavement heating are enhanced if the initial pavement temperature is lower. To recreate the most conservative scenario, the test slabs were cooled down to just above freezing (34°F) before each exposure cycle.
